CCA Treated Wood

The End of the Line

MSW Management

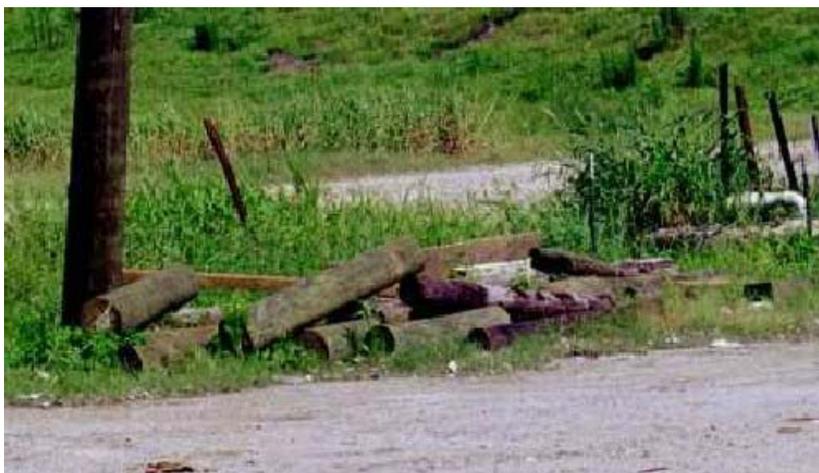
Telephone Poles Photo: Florida DEP

Larger pieces of CCA treated wood used for industrial purposes, such as railroad ties and utility poles, are easily identifiable. But smaller pieces from residential use are harder to find and pull out. Not quite a needle in a haystack, but close. Even with smaller pieces, it's often the shape of the material that's used to determine whether it should be pulled from the pile. If wood waste looks like it came from outdoor decking or fencing, it should be pulled to the side.

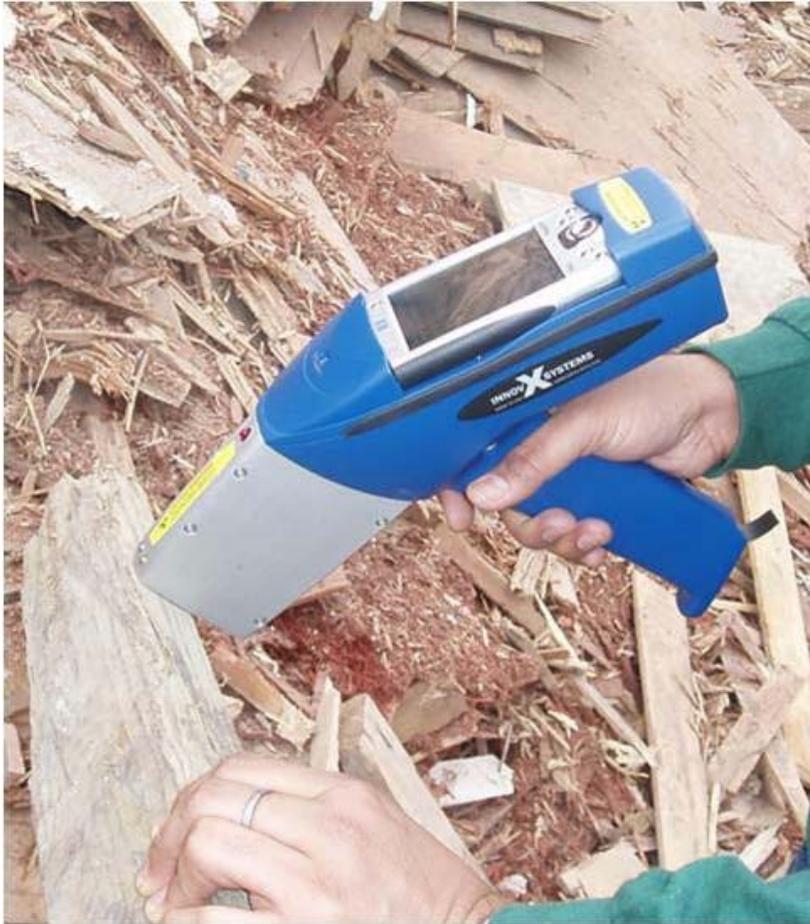
XRF Gun Photo: Helena Solo-Gabriele

Another method used to identify treated wood is x-ray fluorescence, or XRF, because each individual element such as copper, chromium, and arsenic has its own measurable fluorescence identifier. By pointing a portable hand held device, shaped like a gun, at the wood, concentrations of set elements can be calculated in a matter of seconds. XRF technology is versatile and has been used on rocks, soil, and even more recently on children's toys.

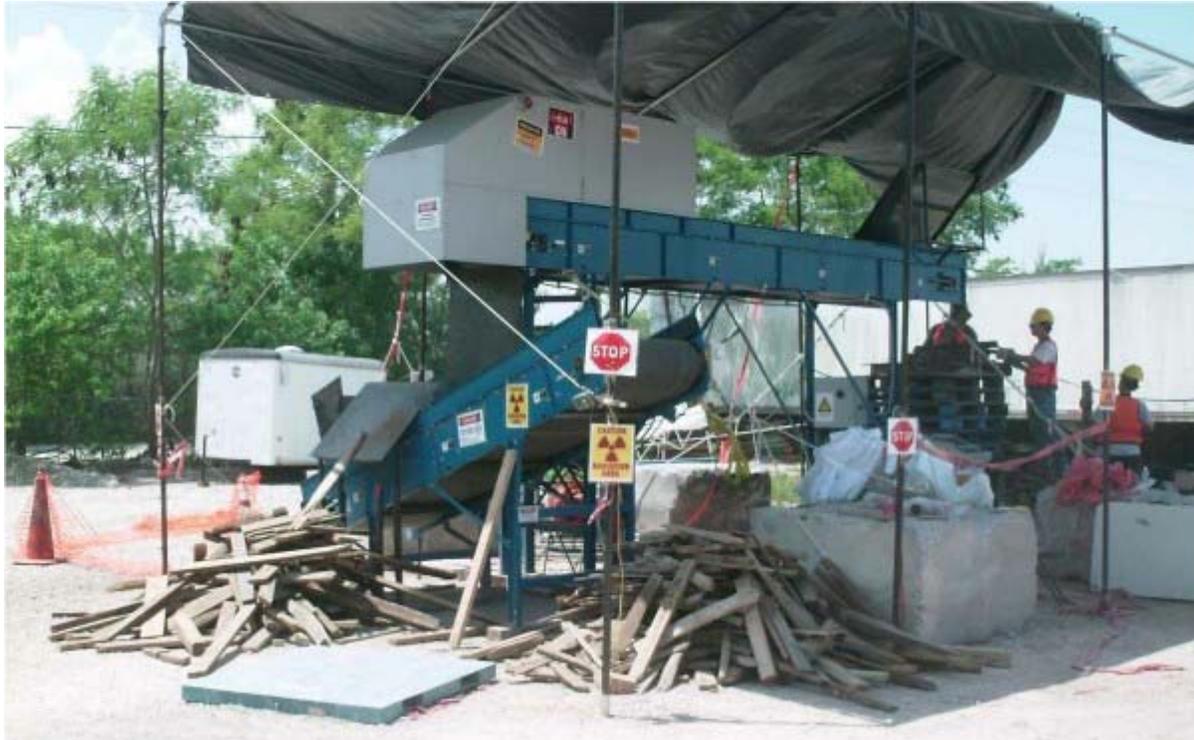
XRF Helena Photo: Solo-Gabriele

But visual inspection is still time consuming. That's why Solo-Gabriele is working on potential full-scale methods to identify and sort out prohibited wood. Solo-Gabriele's pilot study employs XRF technology to effectively identify and ultimately sort CCA treated wood from an incoming stream. Her efforts utilize an on-line configuration, as opposed to a hand held version of the equipment, as its more amenable to full-scale application.

Solo-Gabriele had considered other technologies for the pilot study, but the identification rates using the XRF were higher than those with visual and PAN indicator. Not only was better separation achieved, the XRF could be used on wet and dirty wood and is able to identify numerous elements in a matter of seconds.

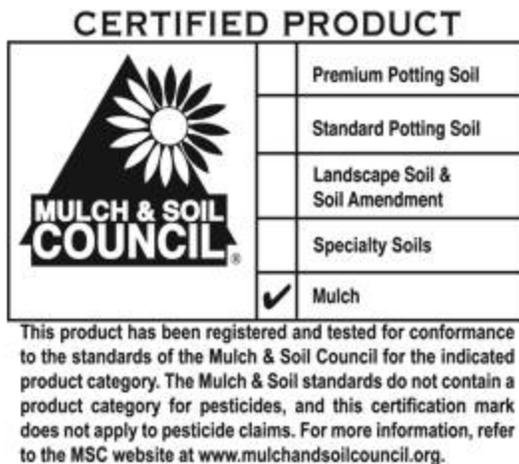
Mulch label Credit: MSC

Products that pass the test are labeled with the MSC certification seal and listed on the council’s website. The council admits that it is not possible to test every bag of mulch, but believes that random testing and exposure of those who violate the certification process has been a deterrent to using CCA treated wood.
